DONLIN GOLD PROJECT

**DONLIN GOLD**
 PROJECT EIS

ALTERNATIVE 2
 MINE SITE: ACMA AND LEWIS
 PIT DESIGN

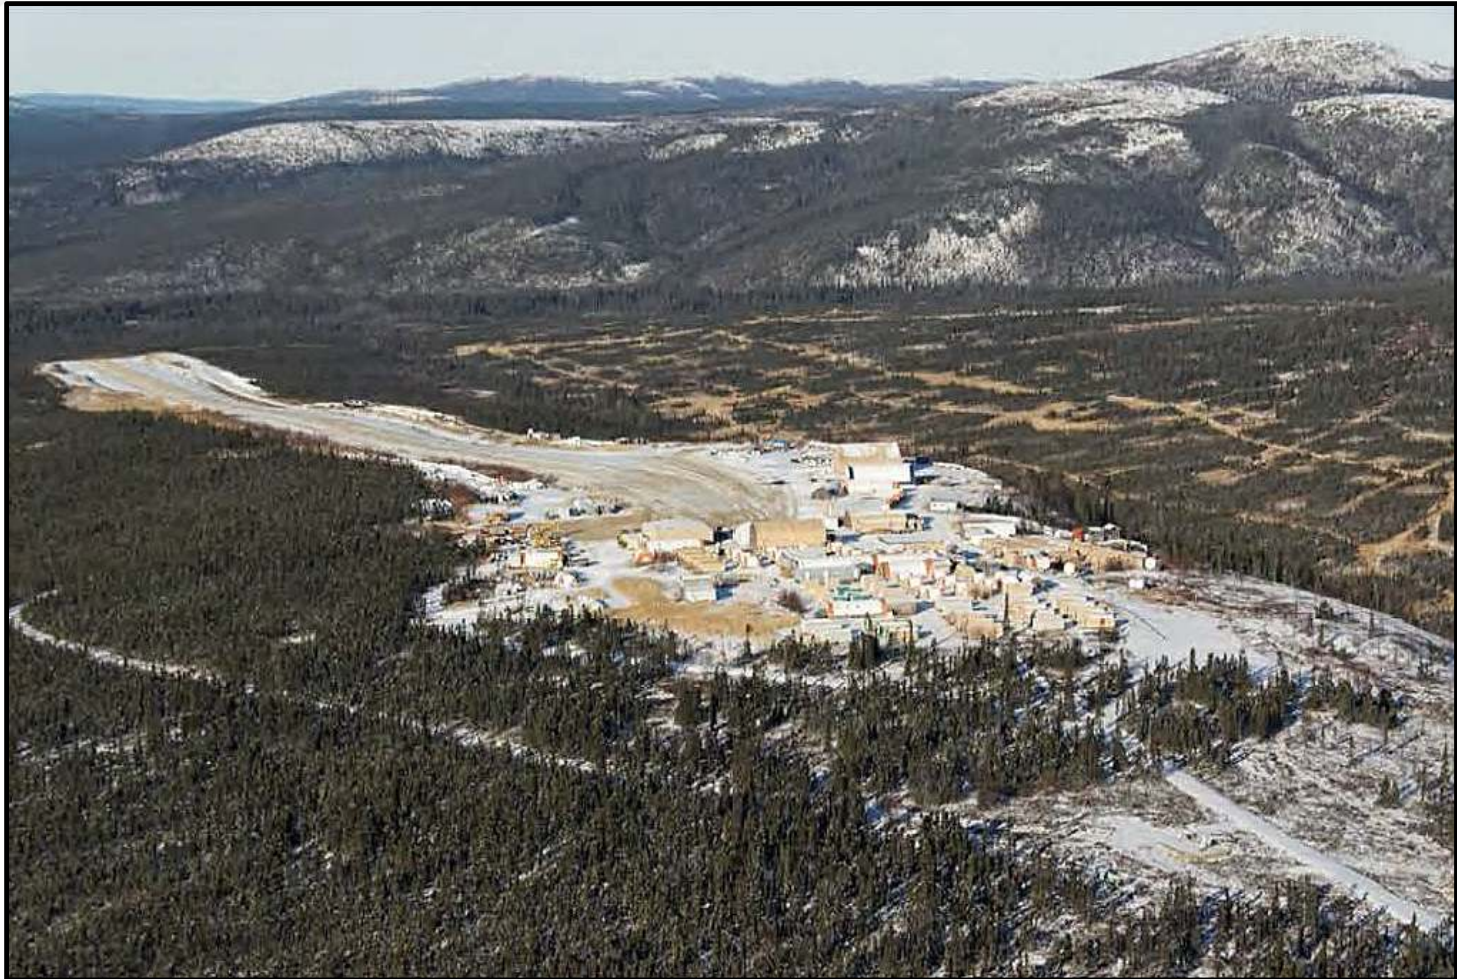
DONLIN MINE SITE (2013)

- Located in SW Alaska, along Crooked Creek, a tributary to the Kuskokwim River.
- One of the biggest gold mines in the world.
- 27-year mine life.
- 1.6 million tons ore.

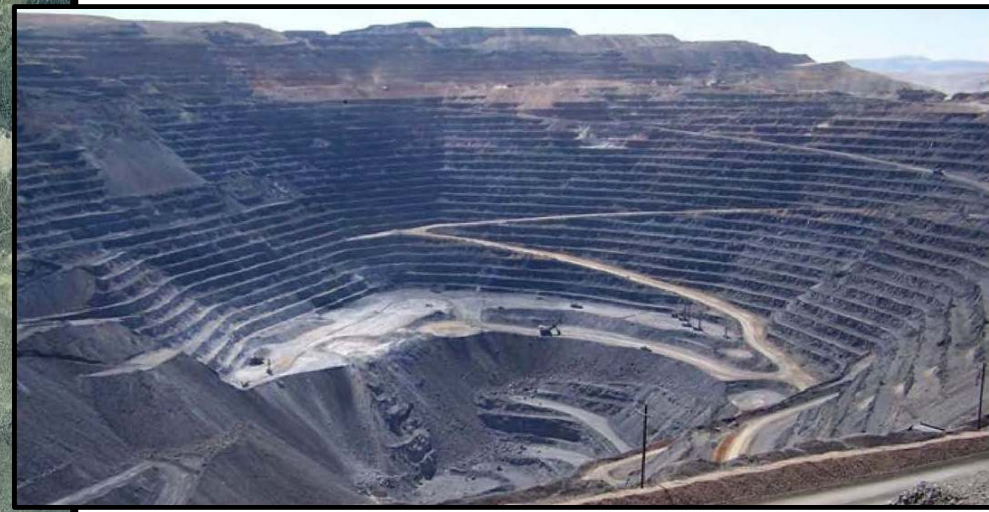
FIGURE 2.3-3

Ultimate Pit Dimensions
 Approximately 2.2 miles long x 1 mile wide
 1462 Acres
 Lewis Pit Depth: 1653 ft
 ACMA Pit Depth: 1850 ft
 Typical Bench Height: 40 ft
 Overall Slope Angle: 23 - 42 deg
 Average ramp width: 131 feet at 10% max grade

ACMA Pit Year 9 Outline

Ultimate Pit Year 22 Outline

- Two pits, ACMA and Lewis, eventually merged.
- 2.2 miles x 1 mile, up to 1800 feet deep.
- 1,462 acres.
- Upon closure, pit will fill up with contaminated water to form a permanent lake that will never meet water quality standards and require water treatment in perpetuity.

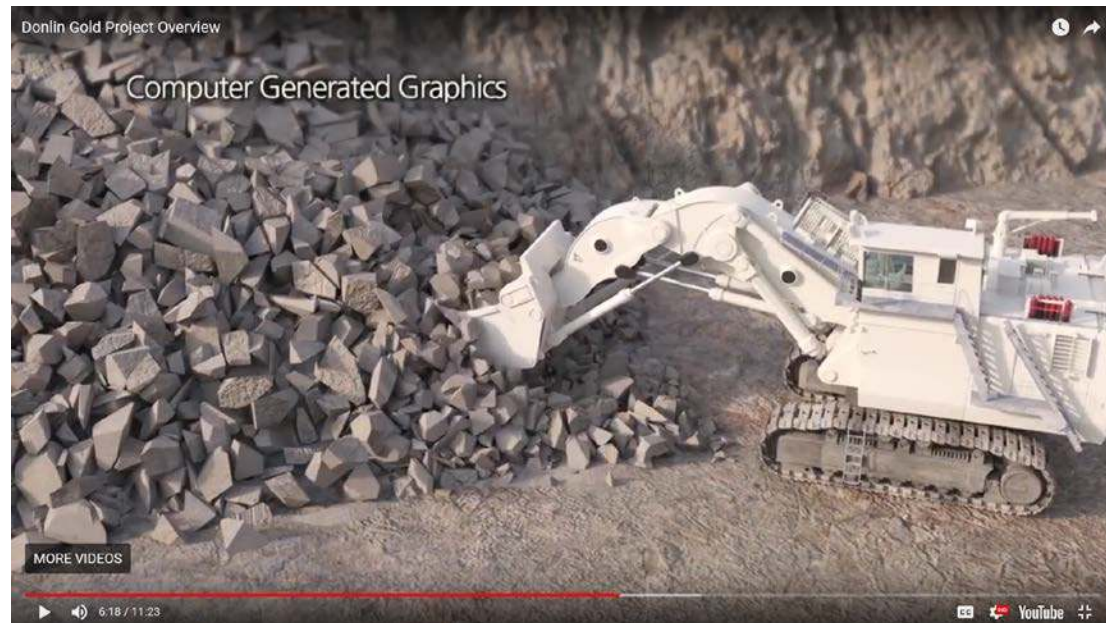
WASTE ROCK

- 2.5 billion tons waste rock, some acid generating.
- 2,500 acres

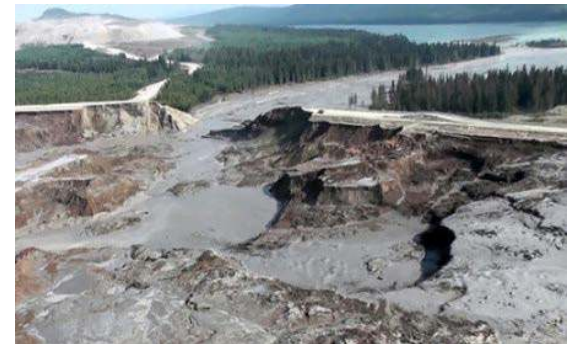
Mt. Polley Dam Failure

- “Mercury belt”—atmospheric deposition
- Arsenic leaching from waste rock to groundwater
- Temperature increases from dewatering
- Risk of tailings dam failure
- Post-closure: perpetual water treatment
